Coal fired plant discovers broken pump with online testing

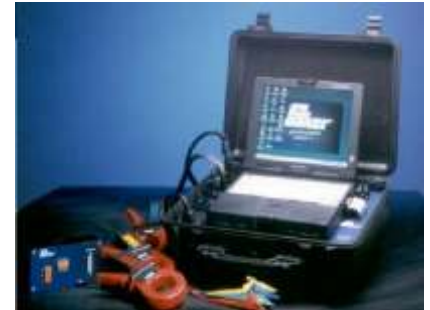
The motor under scrutiny was one of three submerged circulating water pumps in a 732 MW coal fired unit. A technician suspected a problem with one of the three pumps. Removal of this pump would have cost \$60,000, and was considered too critical for operations to stop for an investigation.

Baker Instrument Company, an SKF Group Company's Explorer II verified that one of the three motors was indeed requesting less input power and subsequently operating at a higher speed. However, the most important information the Explorer provided the plant was the instantaneous torque signature of the three compared motors. This reading provides a snapshot of the amount of power requested of the motor by the load. It is the only way to independently test whether a problem lies in the motor or in the load. *The torque signature cannot be captured with any other modern testing equipment.*

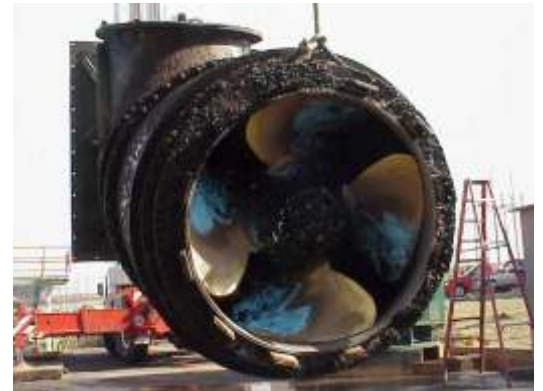
Figure one shows the torque signature of a healthy operating pump, as compared to figure 2 which shows the third pump in the trio. As you can see, the pump under question has a torque of about 75% of the torque of the healthy pumps, meaning it was operating well below its potential efficiency. In addition the torque band is too wide and varies dramatically. All of this information captured by the Explorer provided conclusive evidence for the removal of the pump, which was not previously a priority. Upon examination by a diver, the plant learned that the end bell of the pump had fallen off, reducing the pumps productivity. It was able to be repaired and returned to full service in a short amount of time.

Immediately following the pump's repair, an adjacent pump broke the shaft and subsequently caused additional damage. Thanks to the explorer's conclusive evidence the other pump had already been repaired and returned to full capacity, so during the five weeks it took to replace the adjacent pump's shaft there was no loss in output. Timely intervention on the first pump avoided \$3.5 Million in lost revenue during the repair of the second pump.
